Woods Hole Oceanographic Institution

U.S. GLOBEC Georges Bank Long-Term Moored Program: Part 1 - Mooring Configuration

December 2005

Technical Report

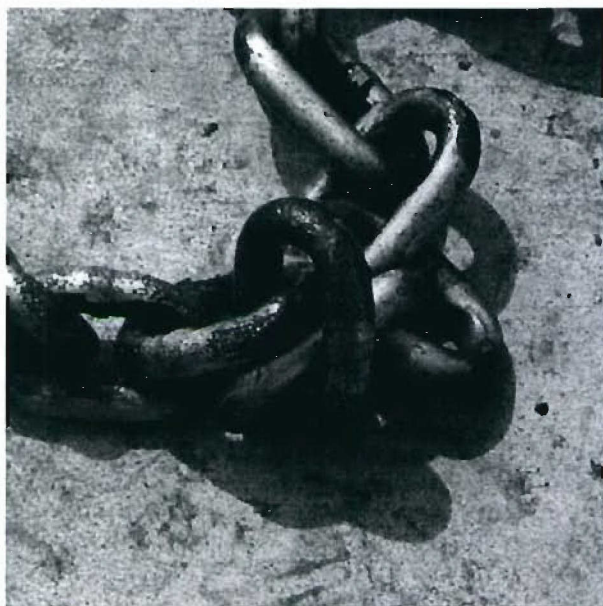
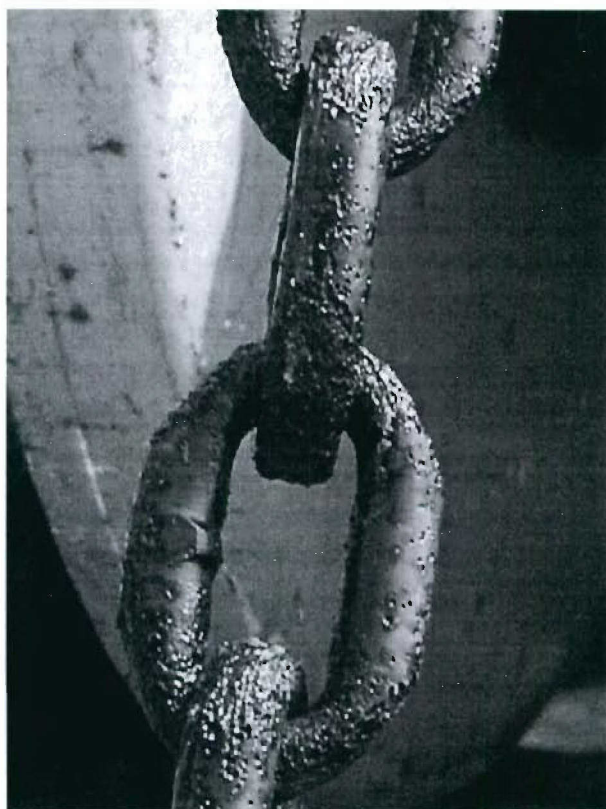
Figure 13. Guard buoy mooring chain. The $\frac{3}{4}$ " chain (upper left) was shiny when recovered. The wear between links is minimal. A recovered anchor (upper right) shows wear due to the motion of the buoy around the anchor. The shackle between the $\frac{3}{4}$ " and $\frac{1}{2}$ " chain (lower left), shows wear on the threads and the nut was only held on by the cotter pin. Finally, the $\frac{1}{2}$ " chain in the water column (lower right) showed pitting and corrosion on the outside of the links, losing up to $\frac{1}{2}$ the material (and strength).

Unlike the elastic tether moorings, the chain catenary mooring hardware showed significant wear during the 11-month deployments. When newly recovered, the $\frac{3}{4}$ " chain was shiny where it was moved about the anchor by the elliptical tidal currents on Georges Bank that effectively removed any galvanizing and corrosion products. The wear in the top of a retrieved anchor (Fig. 13 top right) showed this continual motion of the buoy and chain around the anchor. The shackles that caused the marks on the anchor, showed little wear, so this was not a significant factor in mooring life. The wear between links (Fig. 13 upper left) is minimal and not a significant problem. However, the pitting on the outside of the chain was the major source of wear and loss of strength in the chain. The chain in the figure was not the most corroded, but about normal or less than normal after 11 months on Georges Bank. Even more surprising was the loss of material on the $\frac{1}{2}$ " chain in the water column that had no abrasive effects of the bottom. The chain appears to be pitted, particularly at the highly stressed corners where the material was bent to form the links, showing significant corrosion and loss of material (Fig. 13 bottom right). This corrosion was the main loss of strength in the guard mooring chain, not wear and tear in the movement of the mooring with the waves.

The most significant problem with the chain moorings was observed (Fig. 13 lower left) at the shackle where the $\frac{3}{4}$ " chain joined the $\frac{1}{2}$ " chain. This was comfortably off the bottom and out of the abrasion of the sand. However, the bolt in the chain shackle was not threaded all the way to the end past the cotter pin hole. The corrosion and movement of the nut wore the threads off the bolt, so that they no longer held the nut in place. In this case (the most extreme example

during GLOBEC) the nut is only held on by the cotter pin, and it was possible to remove the nut by hand, meaning that the cotter pin would be the only thing holding the mooring together. The movement of the bolt with the loose nut, wore the holes in the shackles to the point that it would

soon be possible to pass the cotter pin through the shackle, and allow the chain to separate. This was never observed to happen on shackle bolts with the threads extending all the way to the end.
